SHEAR BEHAVIOR OF GREEN CONCRETE BEAMS REINFORCED WITH BASALT

FRP BARS AND STIRRUPS

A Thesis Submitted to  
the College of Engineering  
in Partial Fulfillment of the Requirements for the Degree of  
Masters of Science in Civil Engineering

January 2020

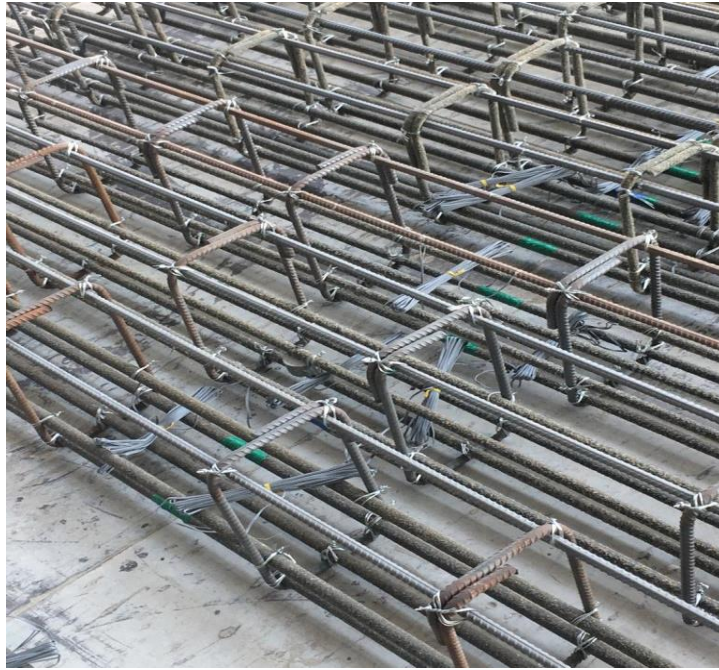
Figure 19. Installation of the strain gauges for the BFRP bars.

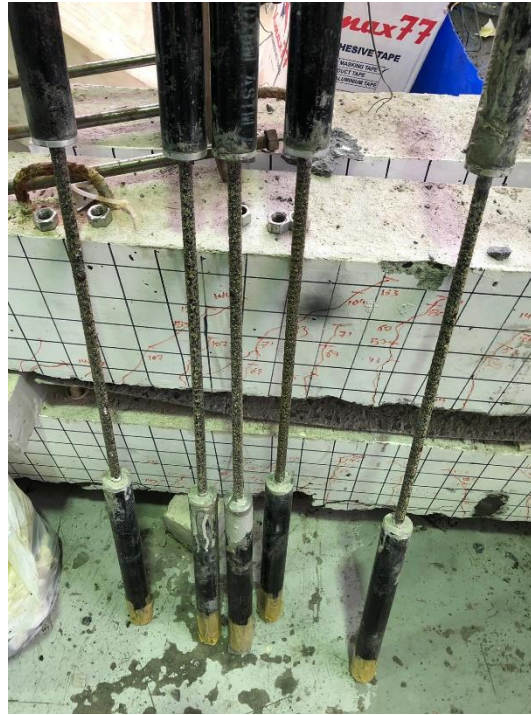
BFRP bars were installed in the center of the steel pipe and the gap has been filled by expansive grout to be used as an end restrainer and to provide the confinement pressure on the bar [26,61]. Procedures have been taken as per ACI-440.15 provisions [26], the steel pipe which have anchors of 305 mm long, the bar length was determined as follows, bar length shall be  $40d_b$  and add to this  $2L_a$ .  $L_a$  tends to the length penetration of the BFRP bar inside the steel pipe (anchorage length) and  $d_b$  tends to the diameter of the bar which will be used in the test . The penetration part of the bar shall be aligned perfectly in order to prevents any undesired failure also plastic caps has been used at both ends of the steel pipe one of the ends was installed with a drilled plastic cab which the bar inserted to ensure that the bar is centered as shown in the Figure 27 (b). The grout was in liquid condition initially then after 24 hours it starts to harden then the specimen can be turned then the second anchor can be prepared.

Figure 27. (a) Tensile test preparation; (b) Specimens of BFRP bars before test.

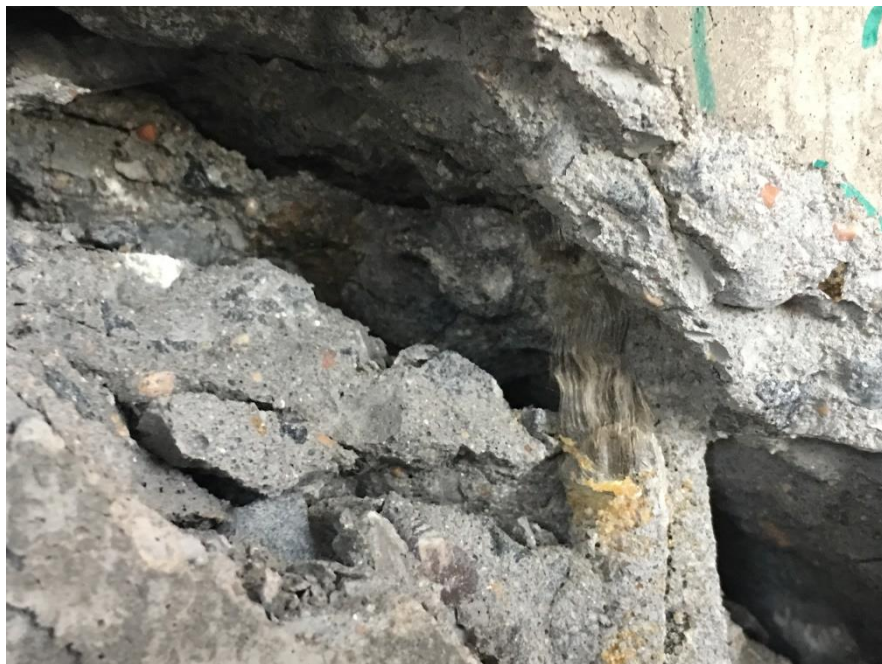
Figure 30. Rupture of the BFRP stirrups.

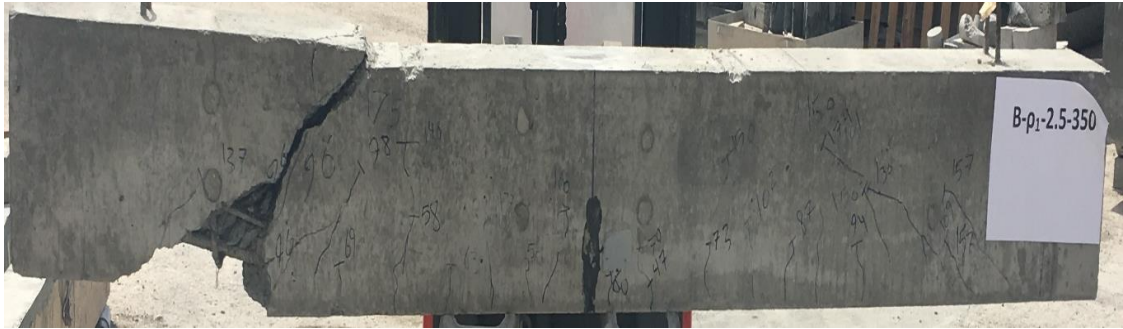
As mentioned earlier that no slip for main reinforcement occur and no spallation of concrete at the failure stage. The maximum mid-span deflection recorded was about 18.1 mm and the maximum compressive strain for concrete was 0.001 however the maximum tensile strain for the BFRP was 0.005.

Figure 31. B-2 Diagonal tension failure.

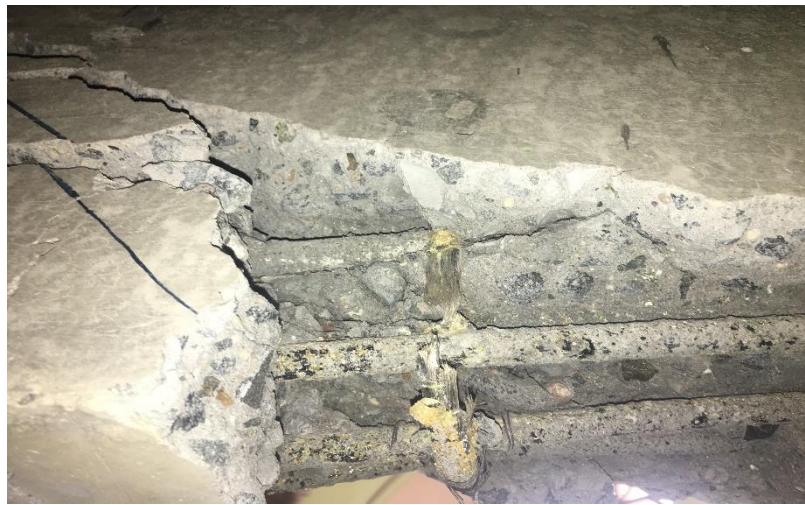
Figure 32. Rupture of the stirrups B-2.

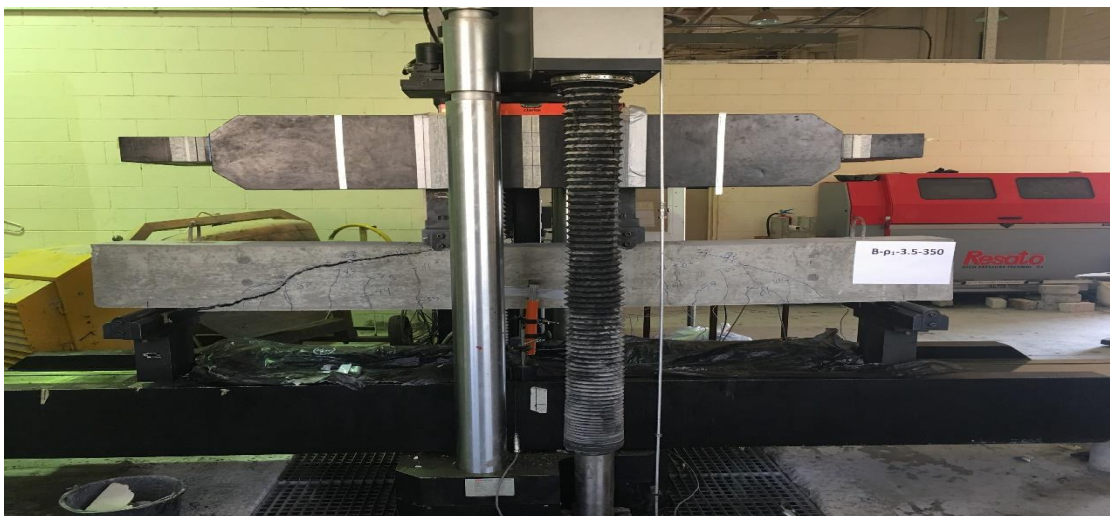
As mentioned earlier that no slip for main reinforcement occur and no spallation of concrete at the failure stage. The maximum mid-span deflection recorded was about 20.26 mm and the maximum compressive strain for concrete was 0.0017 however the maximum tensile strain for the BFRP was 0.0075.

Figure 33. Beam B-3 Diagonal tension failure.

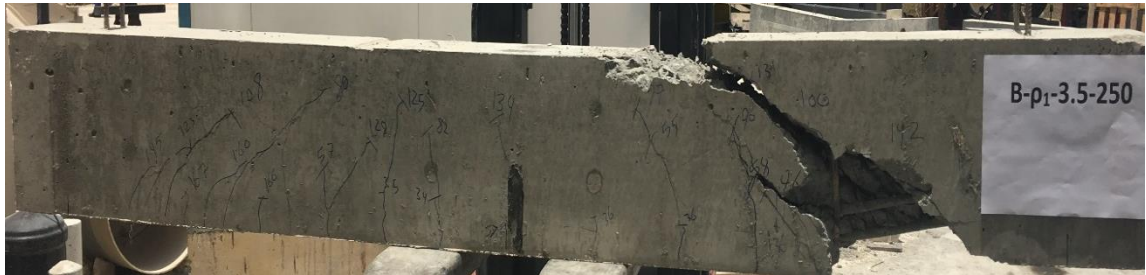
compressive strain for concrete was 0.003 however the maximum tensile strain for the BFRP was 0.012.

Figure 34. Beam B-4 Shear compression failure.

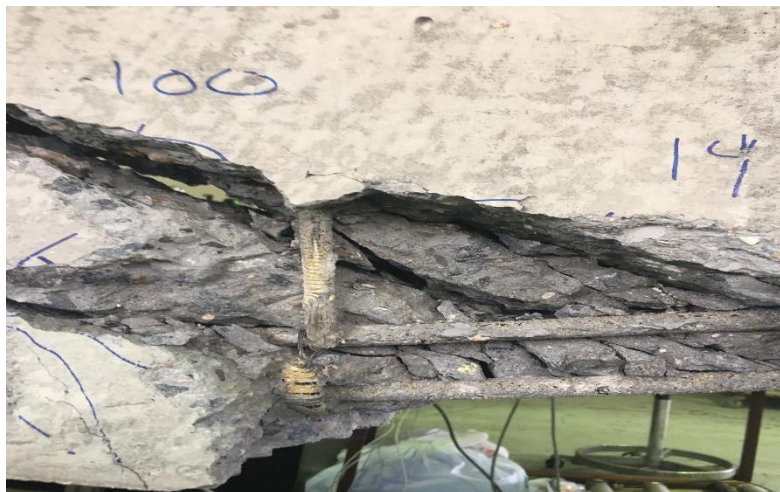
Figure 35. Rupture of the stirrups B-4.

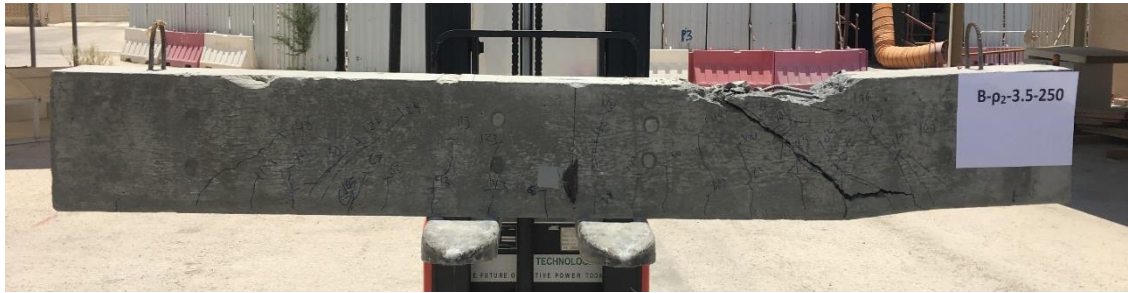
Although it was noticed that there was no spallation of concrete occur at the failure stage. The maximum mid-span deflection recorded was about 28.2 mm and the maximum compressive strain for concrete was 0.0027 however the maximum tensile strain for the BFRP was 0.008.

Figure 36. Beam B-5 Shear Compression failure.

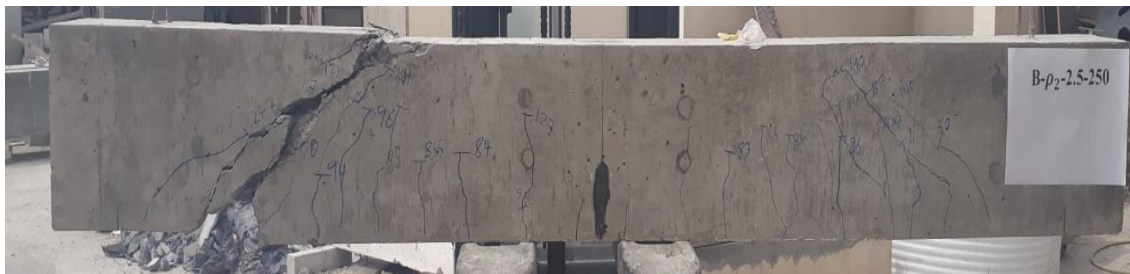
As mentioned earlier that no slip for main reinforcement happen during the test and no spallation of concrete occur at the failure stage. The maximum mid-span deflection recorded was about 28 mm and the maximum compressive strain for concrete was 0.0026 however the maximum tensile strain for the BFRP was 0.007.

Figure 38. Beam B-6 Diagonal tension failure.

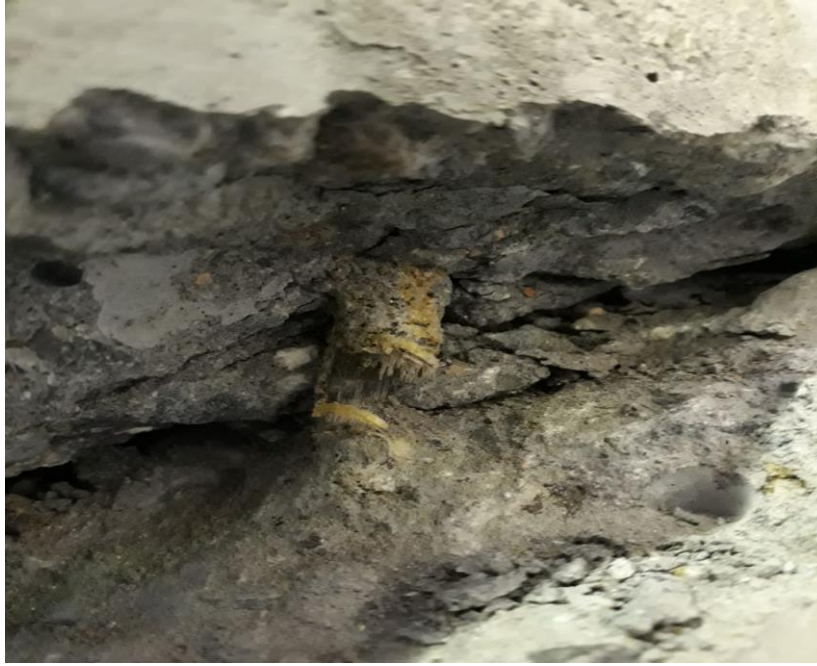
Figure 41. Rupture of the stirrups B-8.

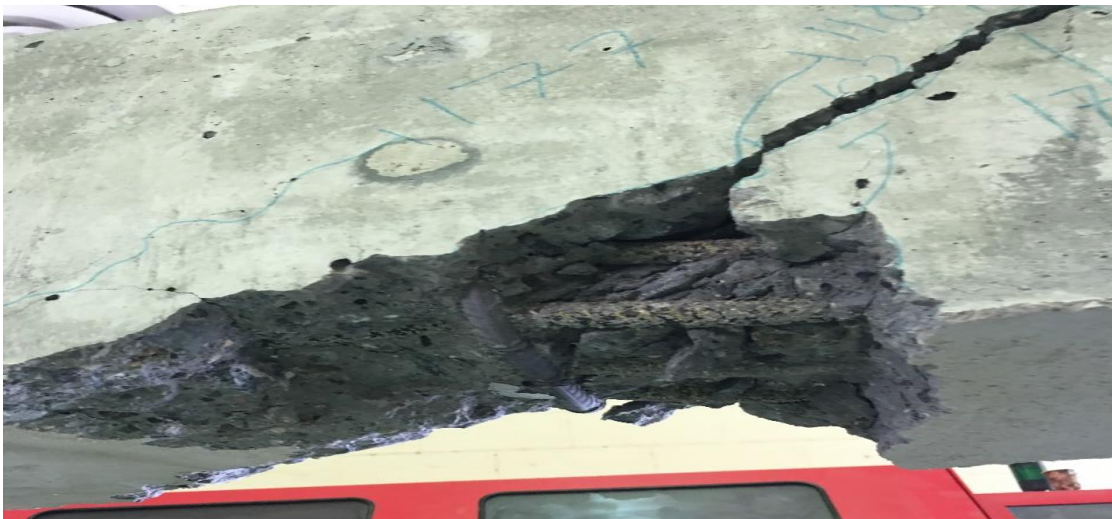
Figure 44. Steel stirrups after failure.

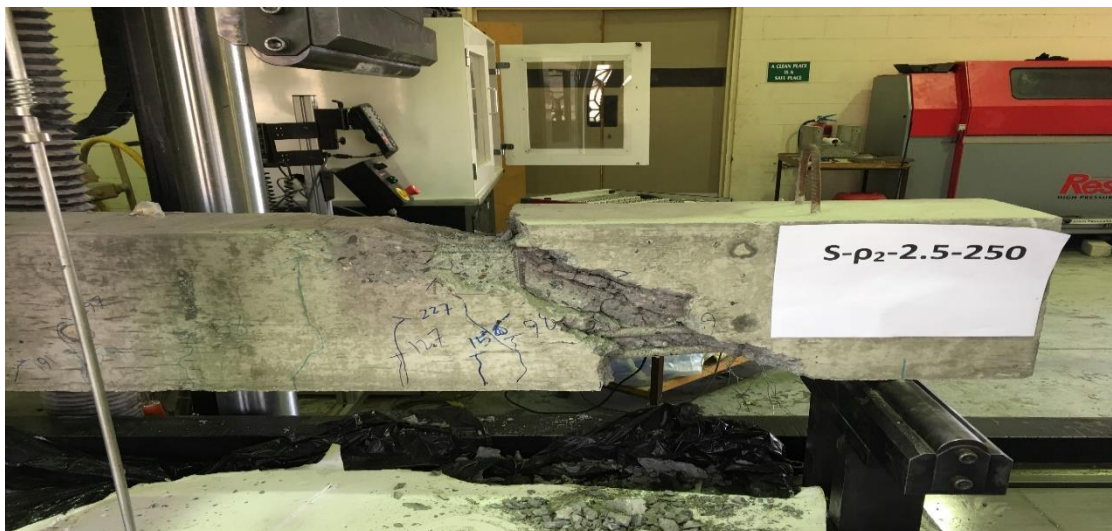
Figure 46. Crushing of the concrete located at the diagonal crack.

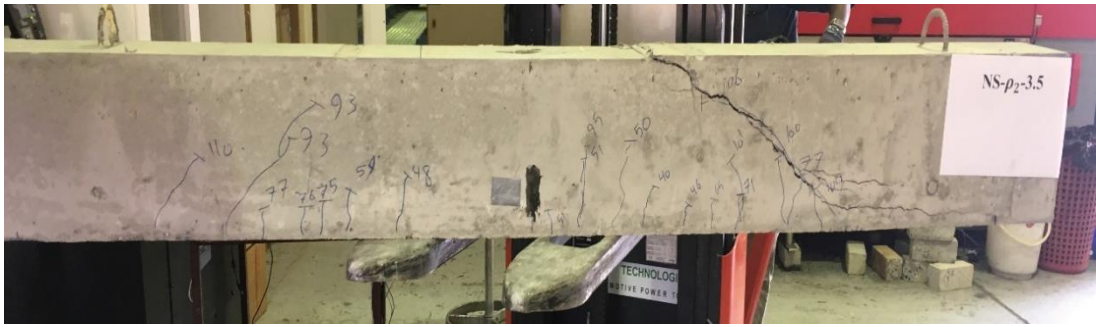
Although it was noticed that there was no spallation of concrete occur at the failure stage. The maximum mid-span deflection recorded was about 13 mm and the maximum compressive strain for concrete was 0.0013 however the maximum tensile strain for the BFRP was 0.004.

Figure 47. Beam B-12 Shear tension failure.

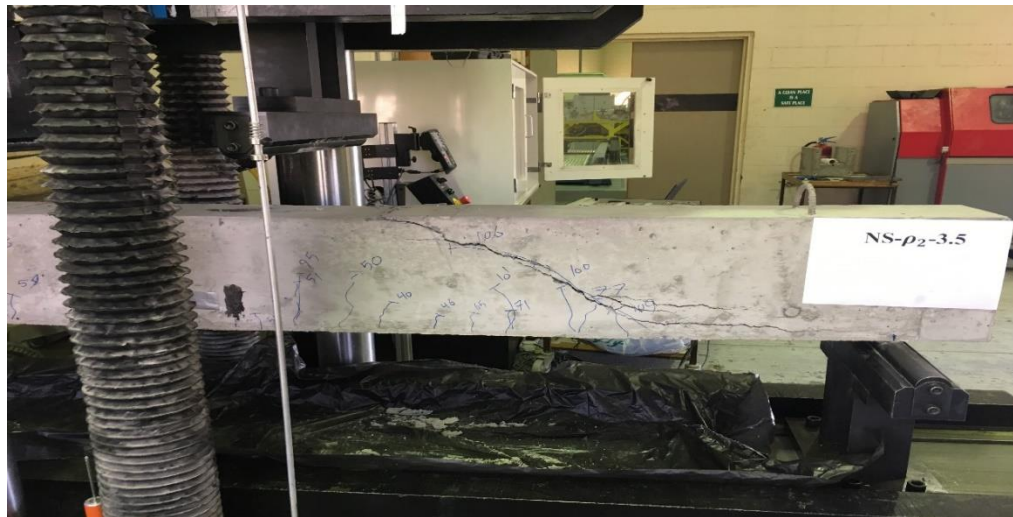
Figure 48. Shear tension failure.

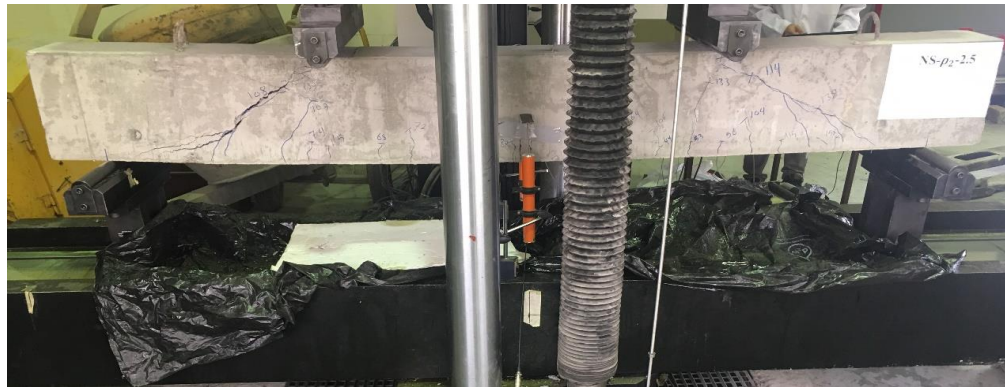
Although it was noticed that there was no slippage for main reinforcement and no spallation of concrete occur at the failure stage. The maximum mid-span deflection recorded was about 17 mm and the maximum compressive strain in concrete was 0.0017 however the maximum tensile strain in the BFRP was 0.0045.

Figure 49. Beam B-13 Diagonal tension failure.
