IMPACT OF PROLONGED EXPOSURE TO SOUR SERVICE ON THE MECHANICAL

PROPERTIES AND CORROSION MECHANISM OF NACE CARBON STEEL

MATERIAL USED IN WET SOUR GAS MULTIPHASE PIPELINE IN QATAR

A Thesis Submitted to

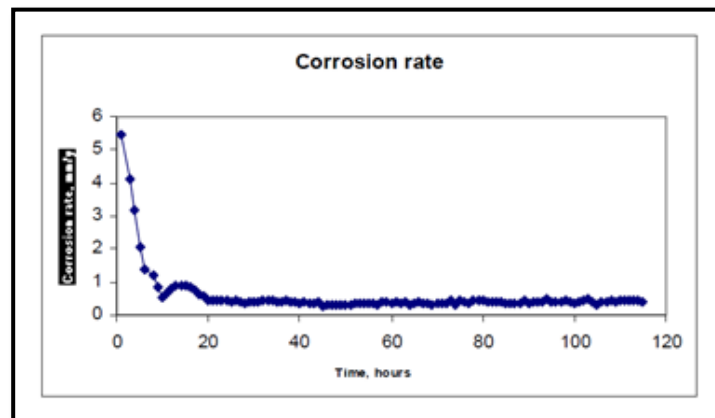
Another mode of failure, which is equally important while selecting and operating in sour service, is wall thinning (Corrosion) associated with sour service (wet gas multiphase pipelines). When carbon steel is exposed to wet sour gas, the initial corrosion rate is very high, which slows down with time due to the formation of iron sulfide scales. A typical plot of corrosion rates versus time [6] using electrochemical techniques is shown in Fig. 1.

Figure 1. Corrosion rate of carbon steel in sour media [6]

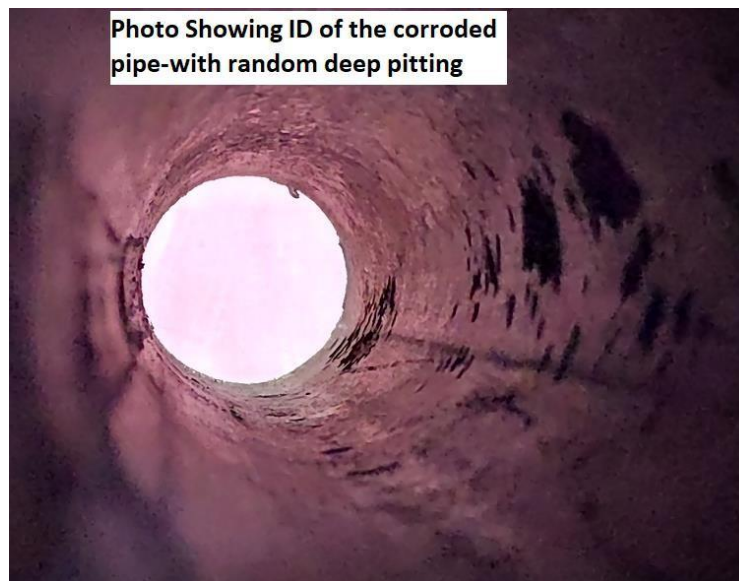
Figure 4. Showing ID of failed spool

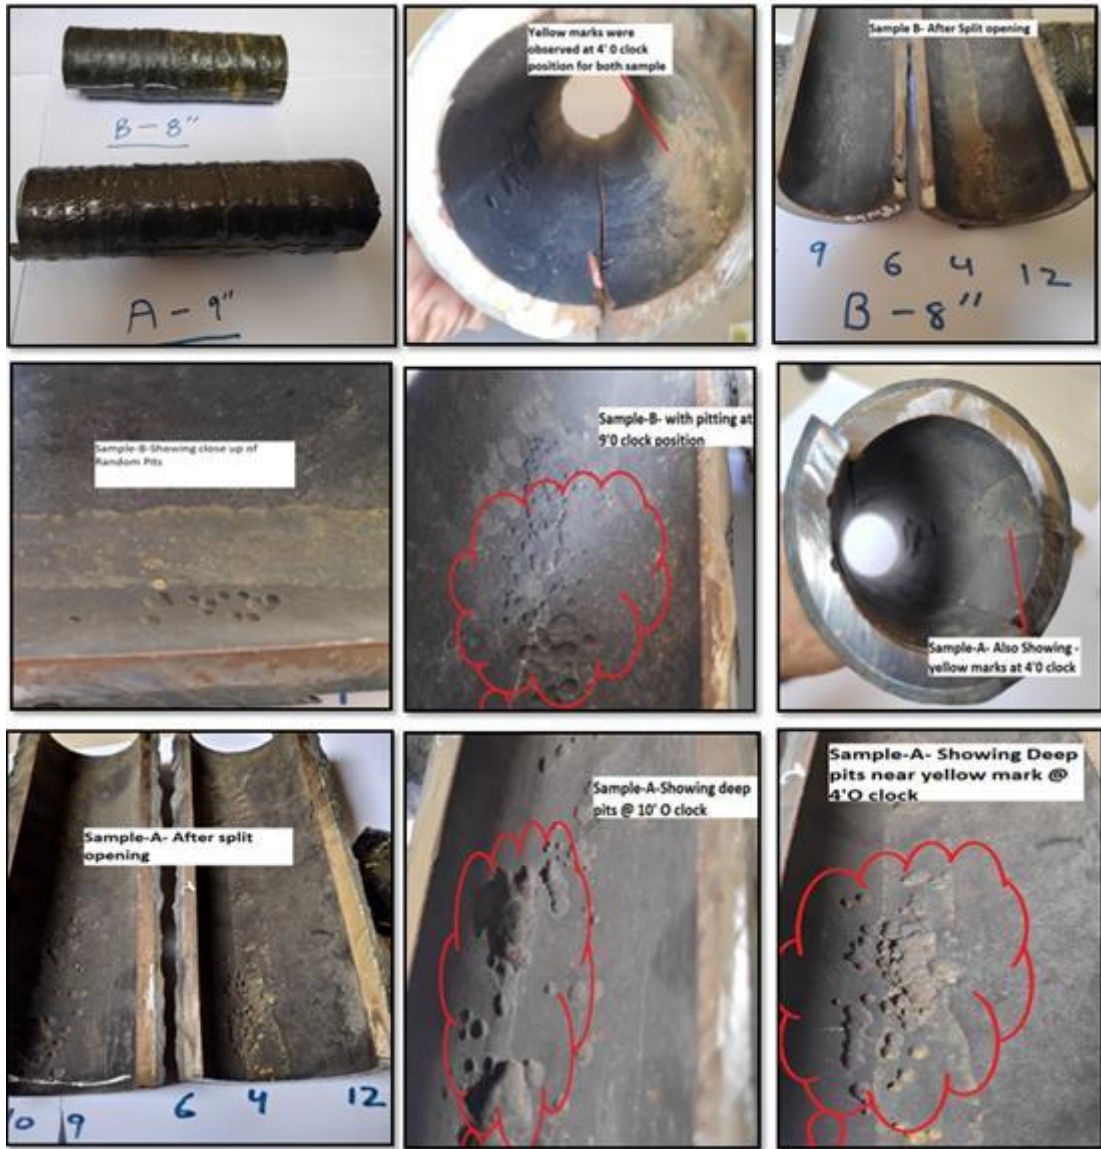
- a) Both samples showed a band of yellow marking @ 4'0 clock position.
- b) Random pitting was observed on both the samples.
- c) The severity of pitting was maximum at 9-10'0 clock position and near the yellow marking.

Figure 8. Micrographs highlighting all critical observations.

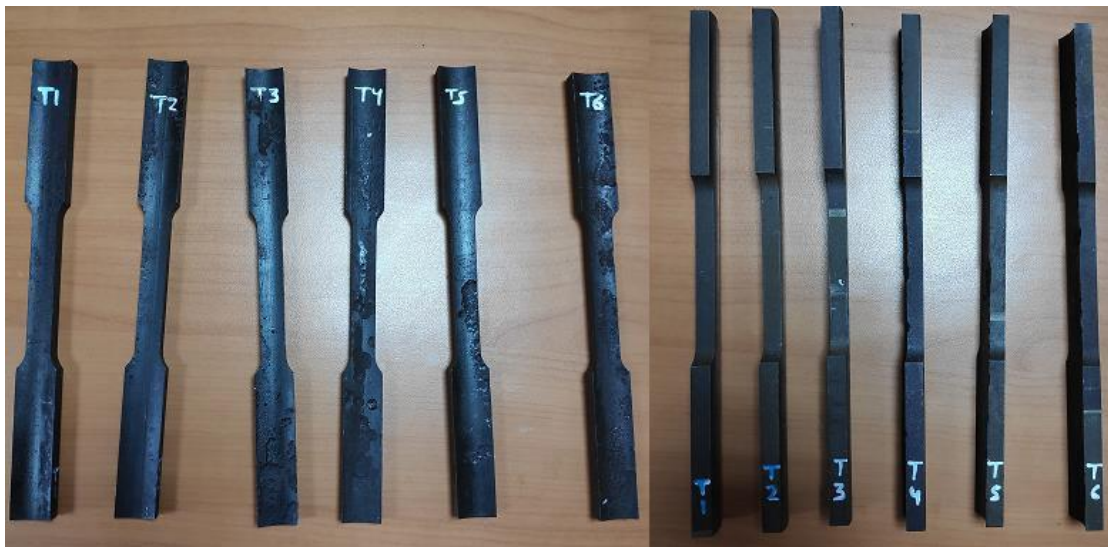
3.2.1. *Tensile Samples:* Six Standard samples as per ASTM standard E8/E8M-16a were prepared. Three samples were without evident thinning/pitting at the reduced parallel section, whereas the other three samples were prepared with the pitting/corroded area within the reduced parallel sections.

Figure 9. Photograph for the tensile samples (T1-T6).

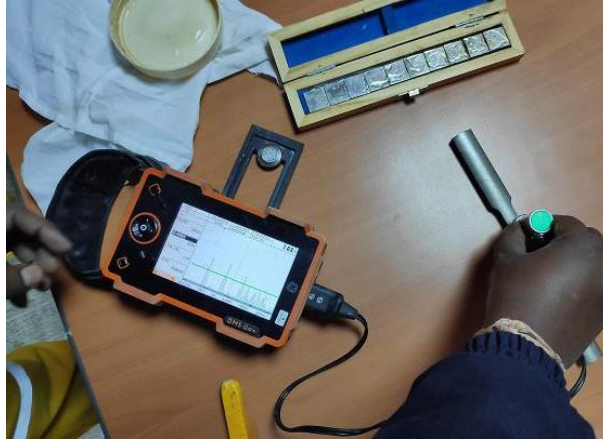
Ultrasonic thickness meter was utilized to measure the actual minimum thickness of the tensile specimens.

Figure 10. UT measurements for identifying the lowest thickness area in corroded specimens.

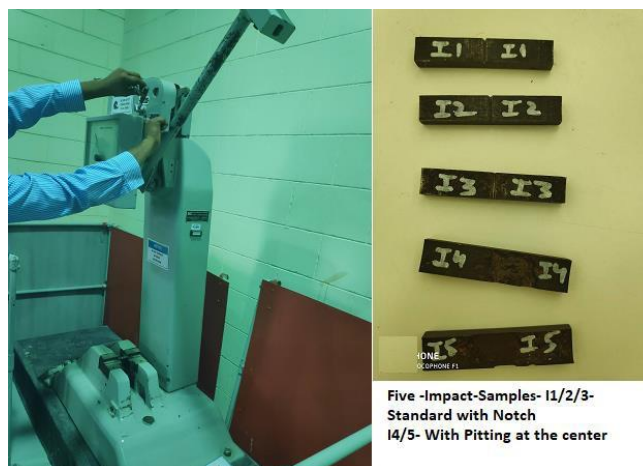
3.2.3. *Impact Samples/Testing*: Five standard samples were prepared as per ASTM standard E23. Three samples were polished and provided with the notch in the center. However, the remaining two samples were prepared without polishing, with the pitted area at the center. Impact testing for all samples was carried out at room temperature by using Avery- Dension, UK –Impact Testing machine.

Figure 12. Photograph for the impact machine and impact samples.

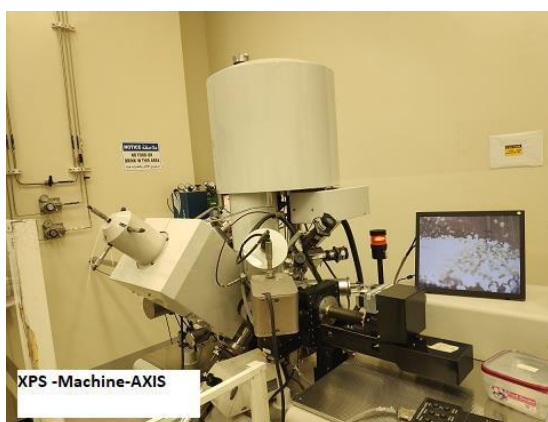
a) **XPS Analysis**: Surface composition of all samples was analyzed by X-ray photoelectron spectroscopy (XPS), Model Axis (Ultra DLD XPS Kratos, Manchester, UK), equipped with a monochromatic Al K α radiation source (1486.6 eV) X-ray Power, 15 kV, 20 mA under a UHV environment (ca. 5x10⁻⁹ Torr). XPS is equipped with a set of chambers to transfer sensitive samples from the sample transfer chamber (STC) to the XPS surface analysis chamber (SAC) which is under ultra-high vacuum.

Figure 13. Photograph for the used XPS machine.

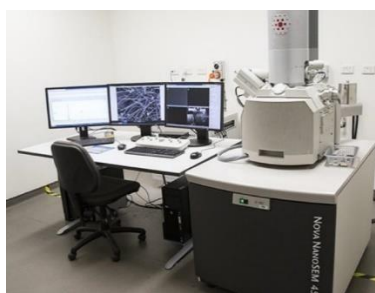
- b) SEM/EDS Analysis:** The SEM instrument used in this work was Nova Nano SEM 450, with a voltage capability ranging from 200 V to 30 kV. All the samples (A1-A6 and B1-B6) were scanned without removing corrosion products or deposits. Additionally, the fractured surface of the two tensile samples (T2 and T4) were compared using this technique to understand the difference in the surface morphology of the failed corroded and non-corroded samples. The scanning electron microscope is a class of microscope that uses focused electron beams instead of light; it scans the surface of the sample and produces an image with an extremely high resolution. Electron/sample interaction produces different forms of signals using Secondary Electrons (SE), Backscattered electrons and diffracted back scattered electrons. Secondary Electrons (SE), are most valuable for showing morphology and topography on samples. And Backscattered Electrons are useful for illustrating contrast in composition in multiphase samples[11].

Figure 14. Photograph for the used SEM machine.

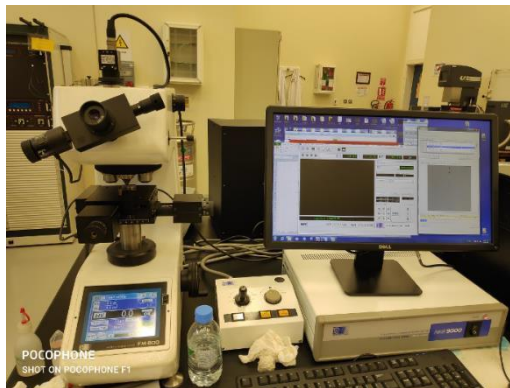
d) **Microhardness & Optical Microscopy:** Two corroded samples were polished, and microhardness was taken across the cross-sectional area to understand the difference in hardness from the inner diameter (ID) to the outer diameter (OD) of the samples. The ID of the sample was exposed to sour service and thus having corroded surface, while as, OD have not directly seen the service fluid. Microhardness is a method of determining a material's hardness or resistance to penetration when test samples are very small/thin [13]. It is used to get precise and detailed information about surface features and its hardness variation. The machine used during testing of samples was FM100. The same samples were utilized to carry out optical microscopy to understand the difference in the microstructure near ID and of the bulk material.

Figure 15. Photograph for the used microhardness machine.

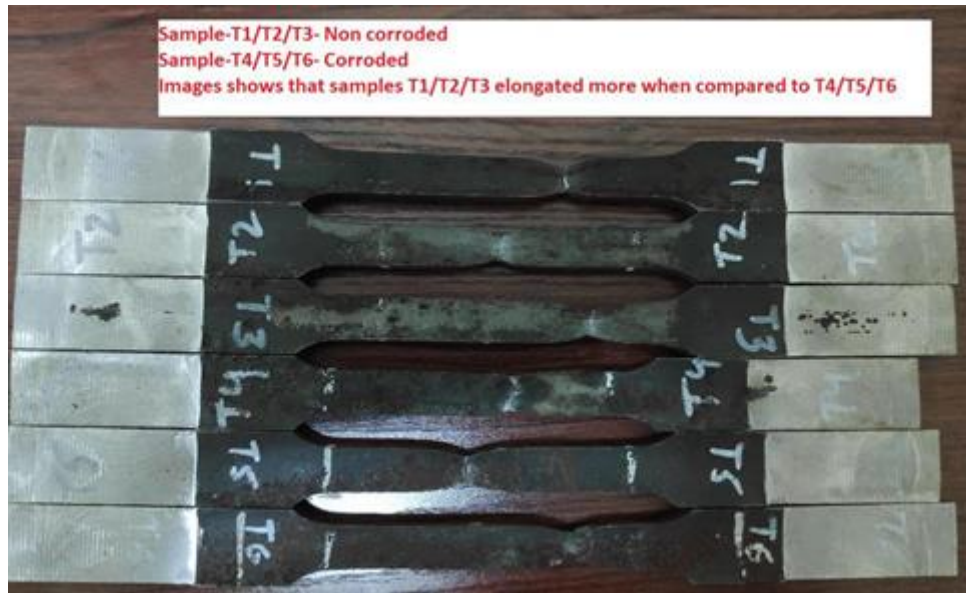
The elongation% values were found significantly higher than the standard values. However, the stark difference can be noticed between the corroded and non-corroded samples. Corroded samples exhibited lower values of % elongation. However, the obtained values were still higher than the standard values. The below photograph shows the elongated length of all failed samples. It is evident that the elongated length of corroded samples (T4, T5, and T6) is lesser than the elongated length of un-corroded samples (T1, T2 and T3).

Figure 17. Photograph for the elongated length of all tensile samples after test.

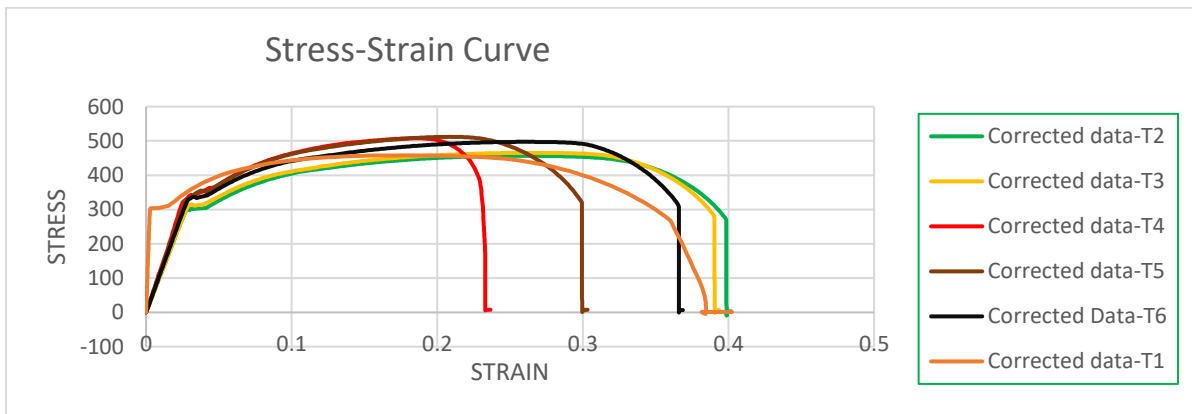
Figure 18. Stress-strain graphs of all tensile samples.

4.1.1. Discussions on the tensile results: Based on the observed results, the loss in yield and tensile strength is evident in all samples (corroded or non-corroded). In wet H₂S environments, the H⁺ ions combine with the electron released by the corrosion of piping and form atomic hydrogen. More active corrosion will yield more atomic hydrogen on the surface of the piping exposed to the sour service. In general, atomic hydrogen can recombine to form molecular hydrogen, which is usually harmless for steel. But this atomic hydrogen

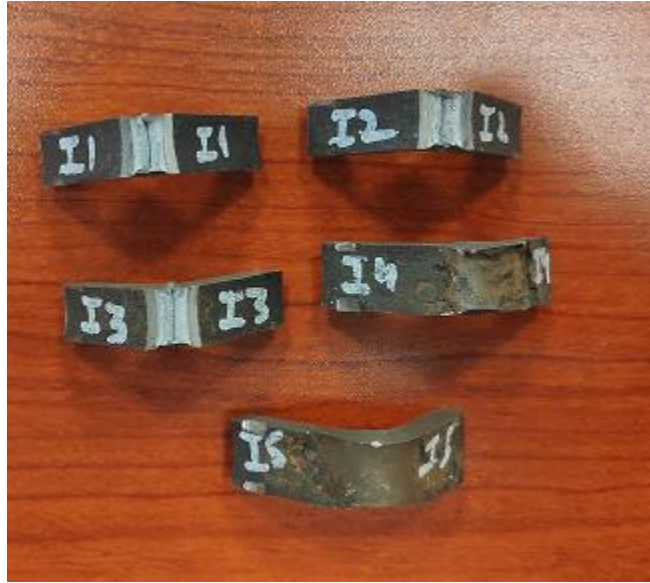
Figure 19 shows the broken Impact samples. It is evident that the samples without notch did not break and absorbed more energy. Additionally, the notched samples were not broken into two pieces. However, as per ASTM standard-E23- “If a fractured impact specimen does not separate into two pieces, report it as unbroken. Unbroken specimens with absorbed energies of less than 80 % of the machine capacity may be averaged with values from broken specimens.”

Figure 19. Photograph for the Charpy specimens after the test.

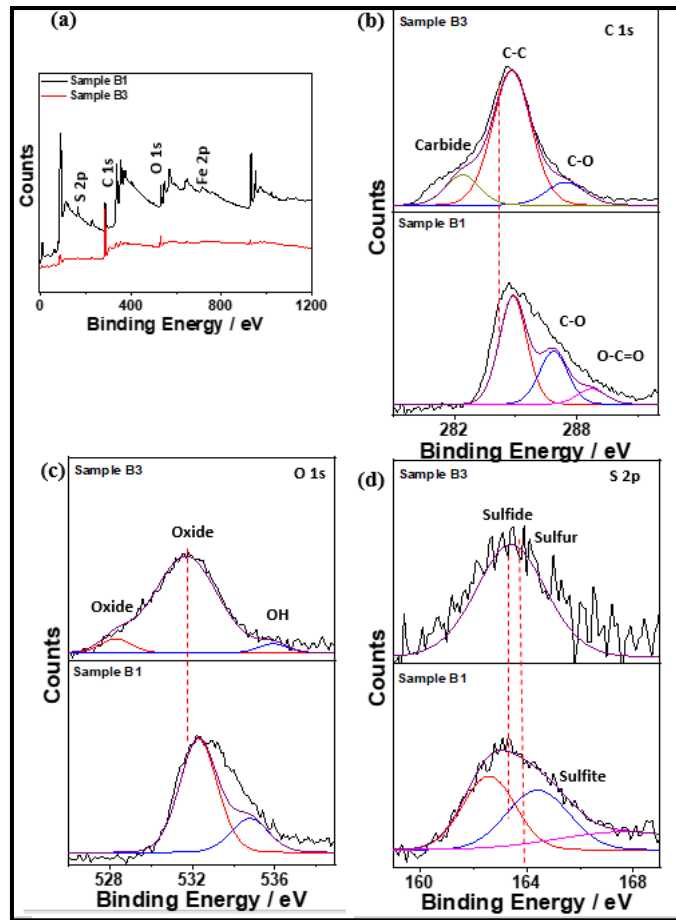
Figure 21. XPS peak fitting for samples B1/B3-a) full survey, b) carbon; c) oxygen and d) sulfur

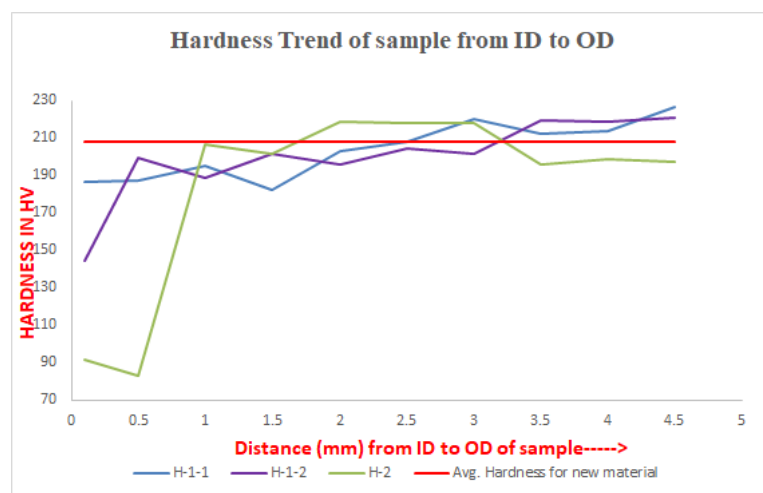
Figure 35. Hardness results of samples-H1 and H2.

4.5.1. Discussions on hardness results: From the hardness data, the low thickness is evident at the ID (near the corroded surface) of the samples. Hardness in the bulk material (at center and OD) is observed similar to the average hardness of new API 5L-X60 material. Loss of hardness is aligned with yield strength, and UTS results got from these samples. This indicates the effect of prolonged in-service environment and active corrosion. The overall mechanical results can be summarized as-loss of strength, and toughness, accompanied by a reduction in hardness (especially at the exposed surface). Similar results were reported by H. Nykyforchyn et al. , and the results were explained by the proposed theory of the development of microdefectness, after 10-20 years of service [3].

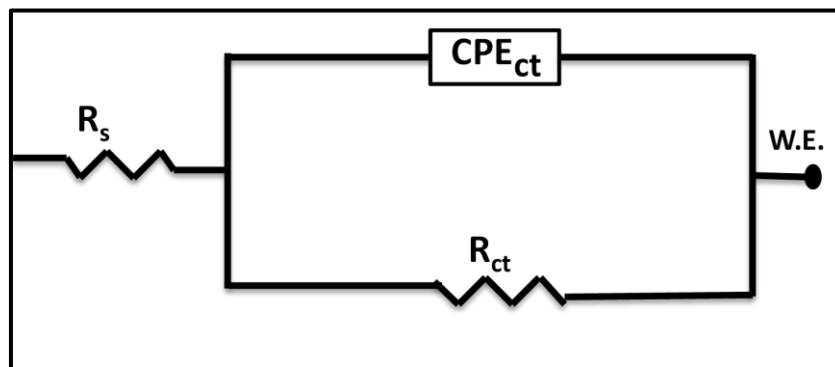
The constant phase element is used in place of a pure capacitor as it is composed of the capacitance and deviation parameter to encounter the imperfectness behavior of a double layer, which may occur because of a non-uniform thickness of the corrosion inhibitor layer, non-uniform corrosion reaction on the surface, or non-uniform current distribution and surface roughness. The capacitance behavior is mainly attributed to the dielectric nature of the surface film (corrosion product and/or inhibitor film) which affects the corrosion rate of the metal, and it can be expressed by the following Equation[27]:

Figure 38. Equivalent circuit (EC) used to fit the measured data.
